Indian and McGregor Creek – Chatham, Ontario (2009)

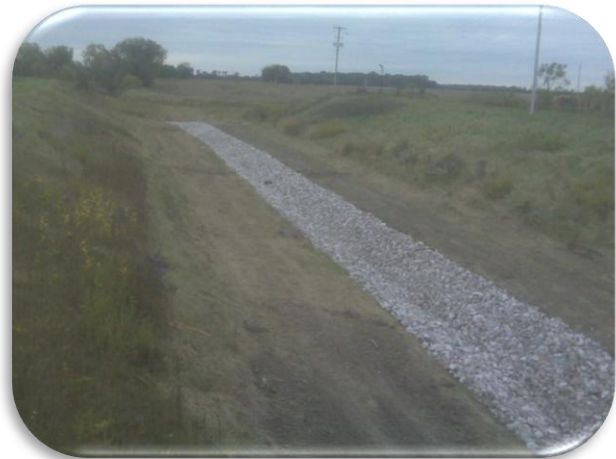
In 1991, a 3.3 kilometre flood control diversion channel was completed to redirect flood waters away from the swollen Indian & McGregor Creeks. This channel has a top width of 50 metres and a depth of approximately 6 metres and uses gates at the headlands of the creeks to allow water into the channel during runoff periods. Over its entire length, approximately 100 drains run into the diversion channel, most of them 150 mm (6 inches) in diameter.

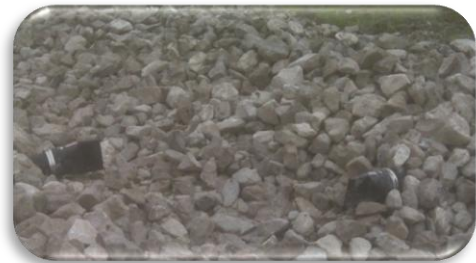
While the diversion channel greatly reduced the incidence of flooding in the greater Chatham area, over time many of the drains leading into the channel began to clog. In 2009, the Indian and McGregor diversion channel was re-trenched and the drains leading into the channel were cleared. In order to eliminate this clogging problem from occurring again, EVR duckbill check valves were placed on the end of each draining pipe. The duckbill check valves further improved the performance of the system since they allow water to

drain into the diversion channel but, when the diversion channel water level is high, will not allow water in the channel to backup through the drain lines.

EVR duckbill check valves have been used in a large number of drainage systems, similar to the Indian/McGregor Creek project, throughout the world.
